Re: Limited Hazardous Materials Survey
Frontier Town Renovations
Schroon Lake, New York
ATL Report No. PL6057CE-01-03-24

LIMITED HAZARDOUS MATERIALS SURVEY

**FORMER FRONTIER TOWN RENOVATIONS
SCHROON LAKE, NEW YORK**

ATL REPORT NO. PL6057CE-01-03-24

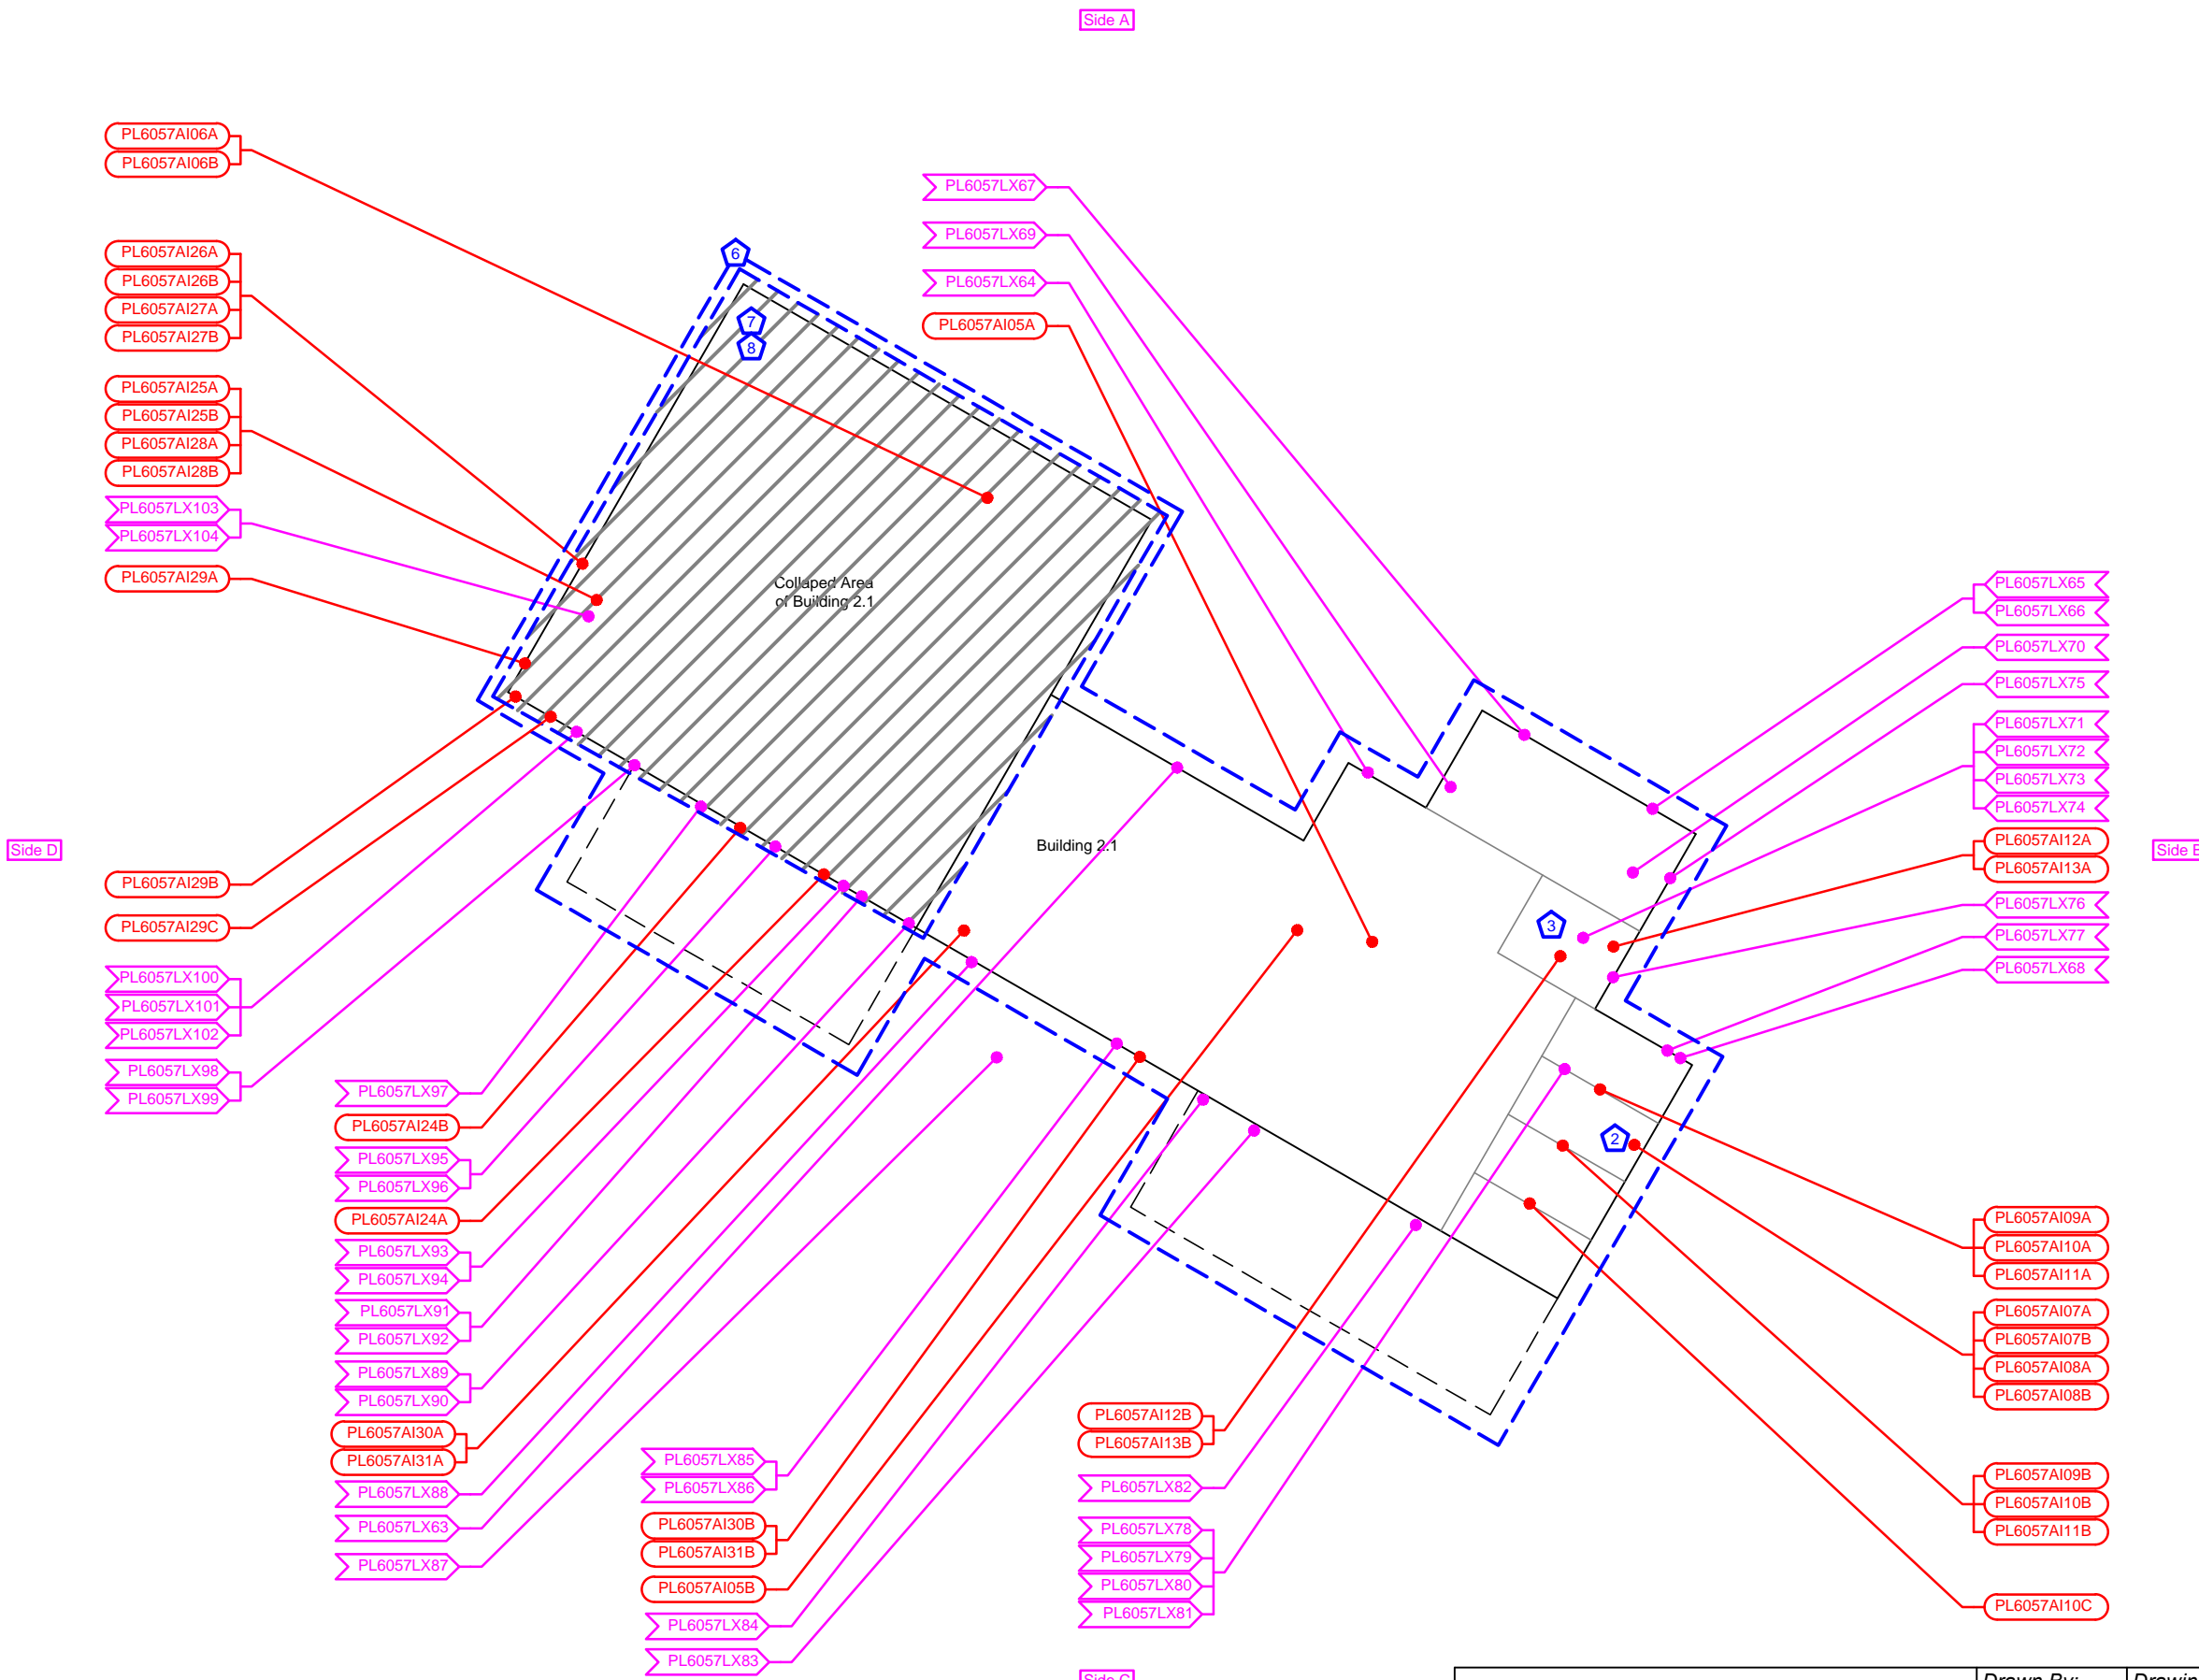
Building 2.1 Sample Location Plan
Scale: NTS

Sections of Building No. 2.1 were collapsed and inaccessible at the time of the limited hazardous materials survey event. Suspect ACM not identified and bulk sampled from the non-collapsed sections of the referenced building will be assumed ACM.

2. **Building 2.1 was determined to be an incidental disturbance and will need to have an incidental disturbance assessment performed prior to any abatement and/or renovation activities.**

- ASBESTOS KEYNOTES :**
- 2 Off-White Sink Coating
 - 3 Gray 9- by 9-Inch Floor Tile
 - 6 Black Paper Vapor Barrier
 - 7 Assumed Inaccessible Building Materials
 - 8 Gray Wall Stucco

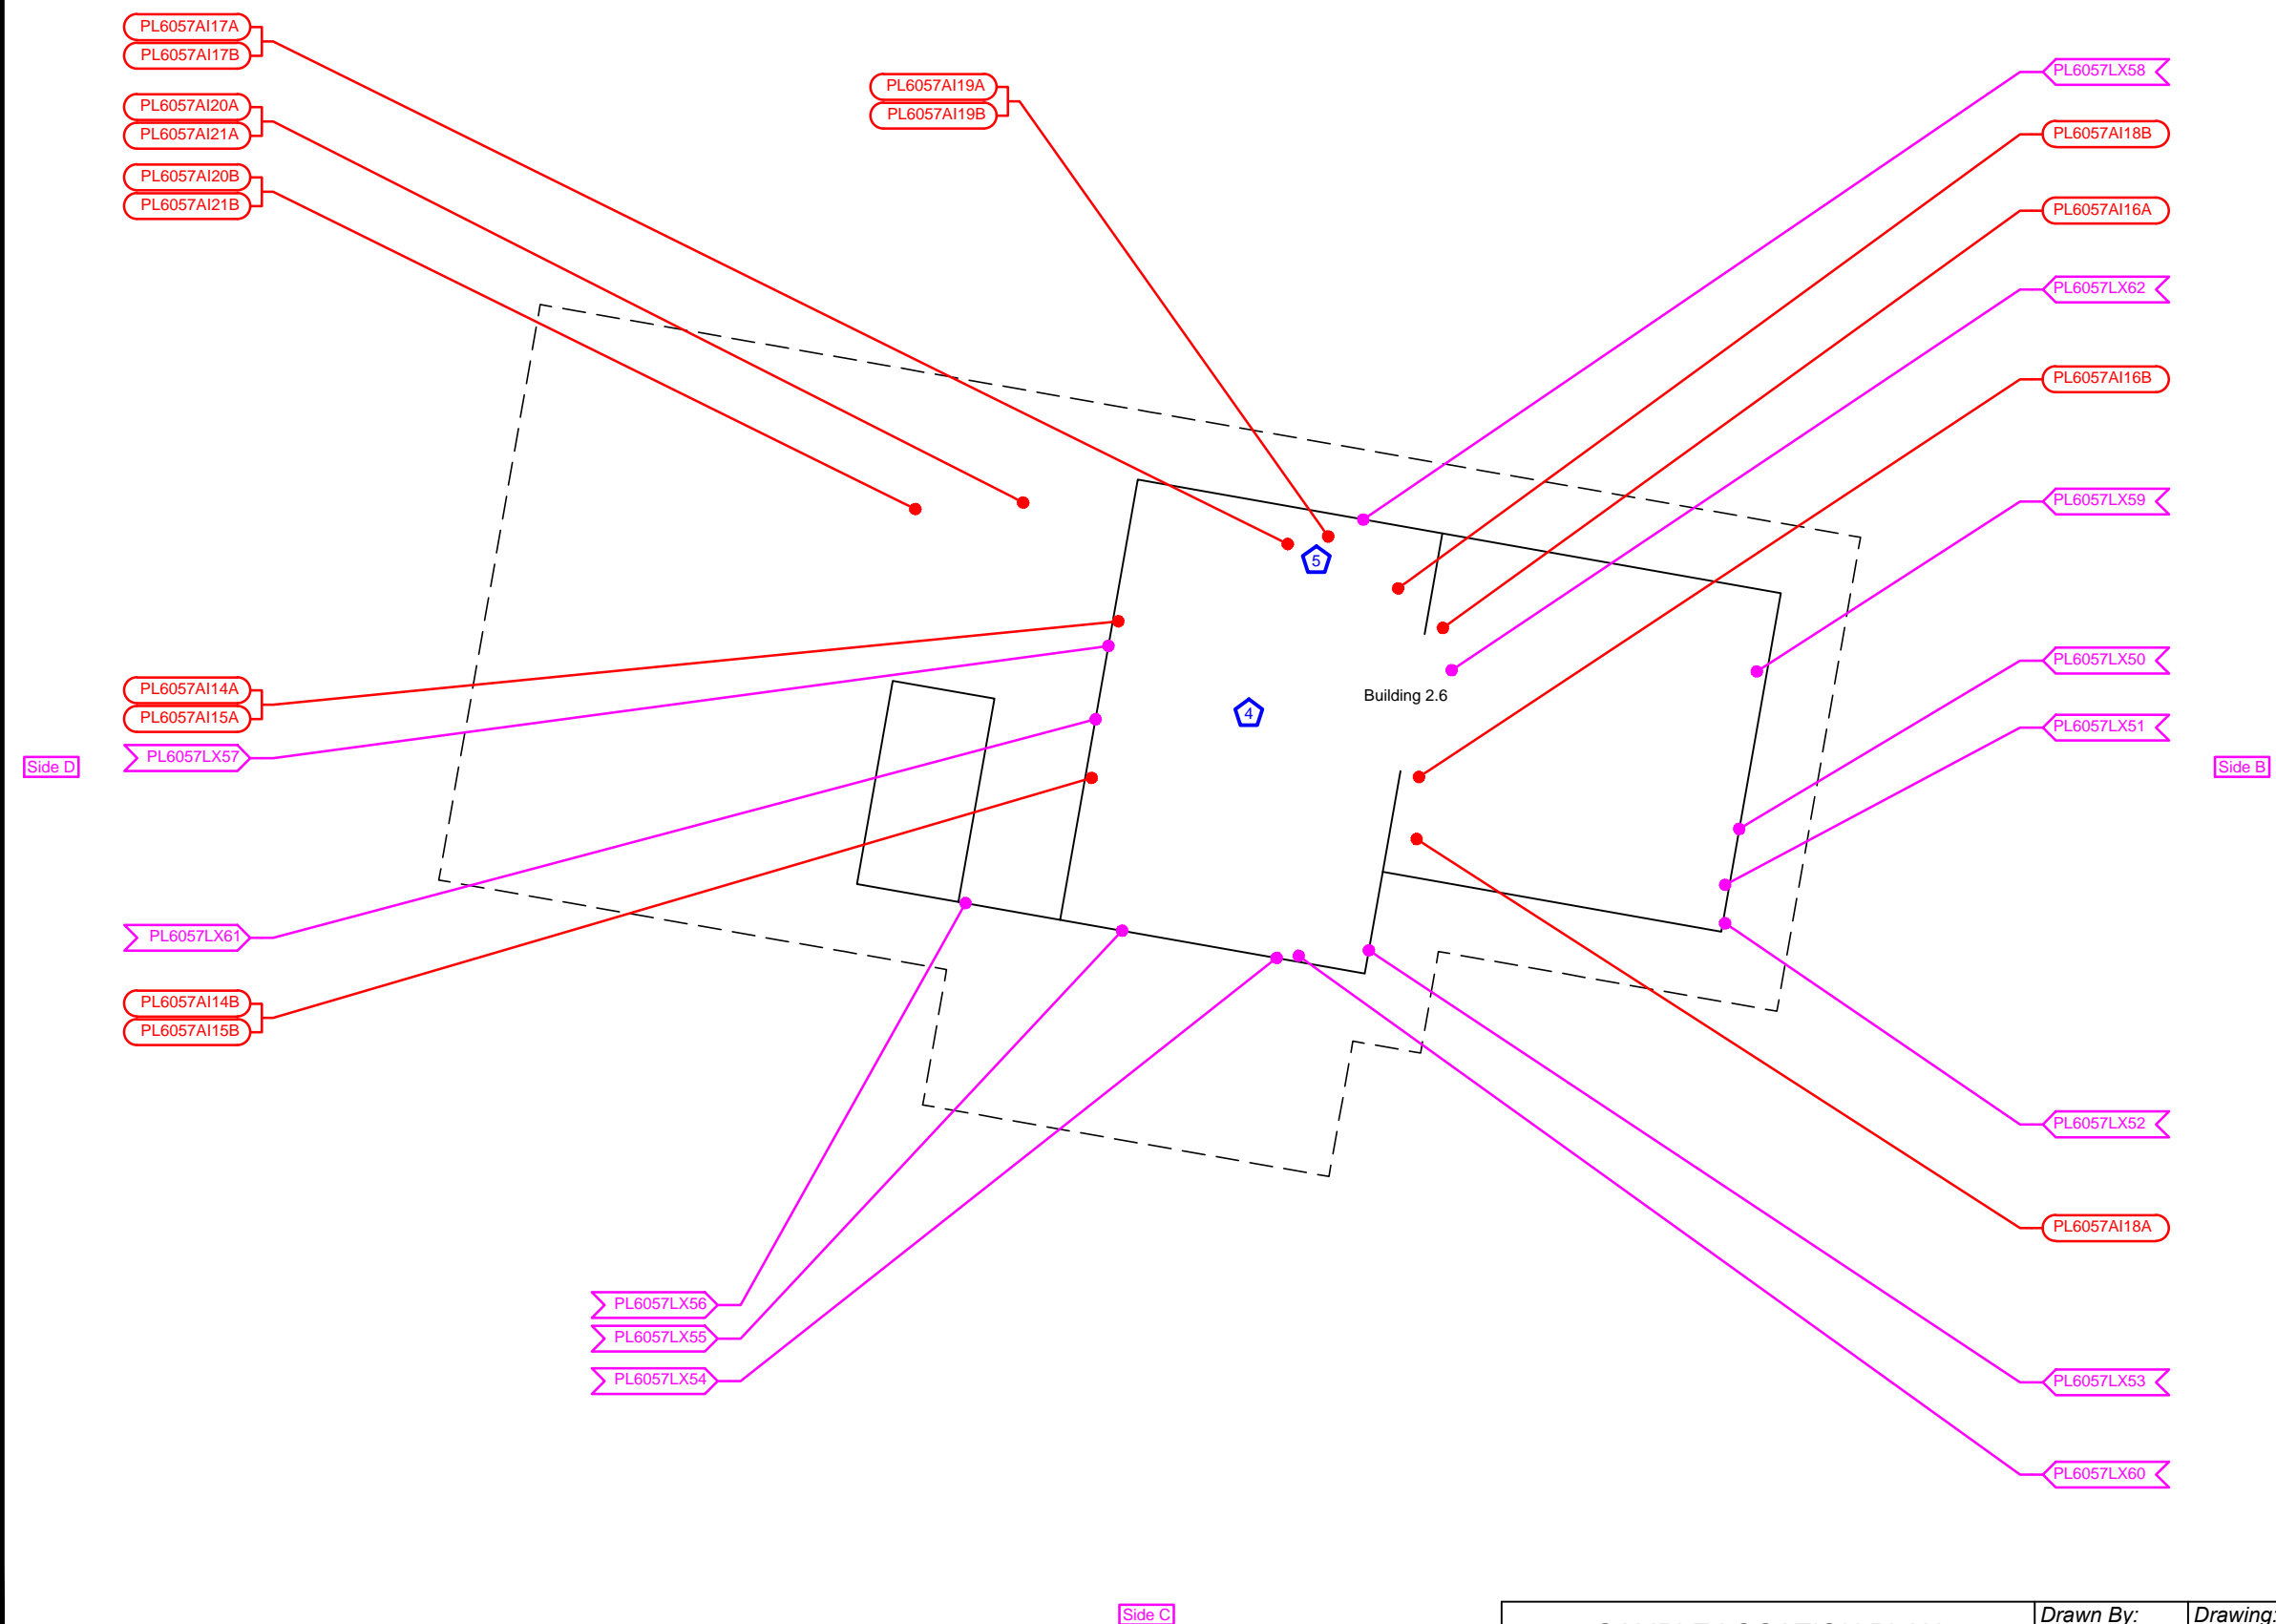
SAMPLE LOCATION PLAN	Drawn By: JDF	Drawing: 1 of 4	Scale: As Noted	Project No.: PL6057	Date: March 2024
-----------------------------	------------------	--------------------	--------------------	------------------------	---------------------

- 4 Gray 12- by 12-Inch Pattern Floor Tile
- 5 Black Sink Coating

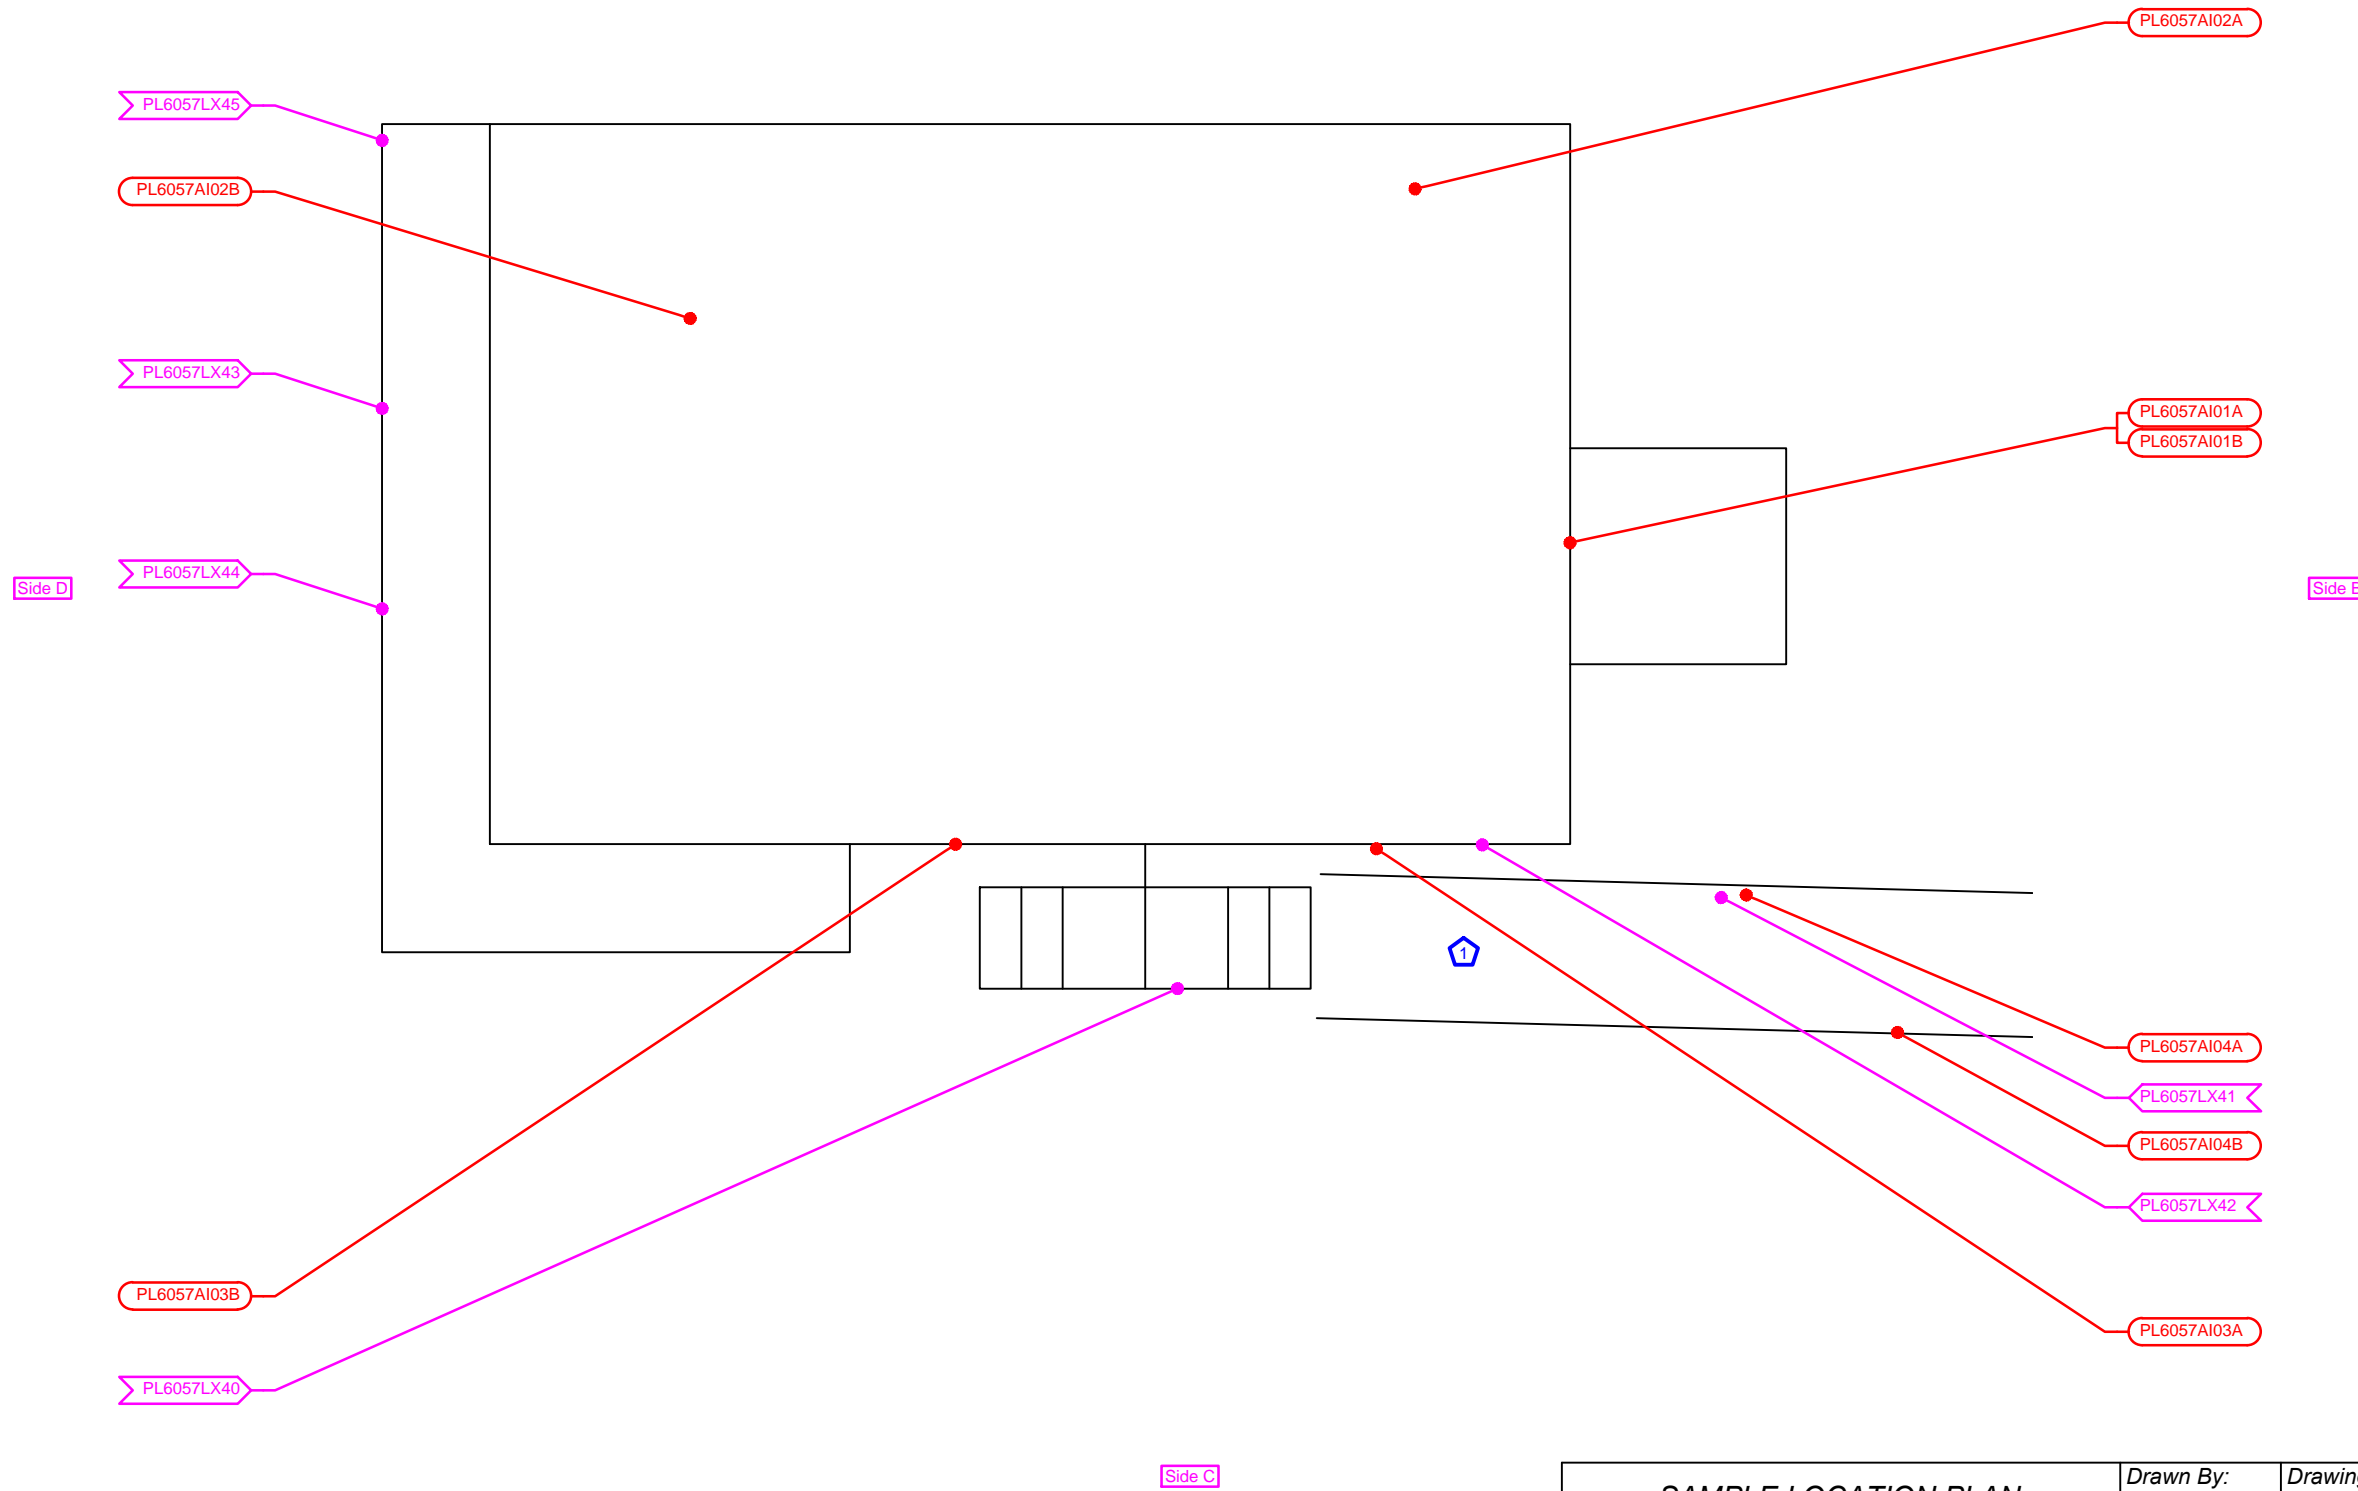
Building 5.2 Sample Location Plan
Scale: NTS

- 1 Black Tar
